Restoration with a side of Roofing

Ice dams lead to major damage inside Michigan home

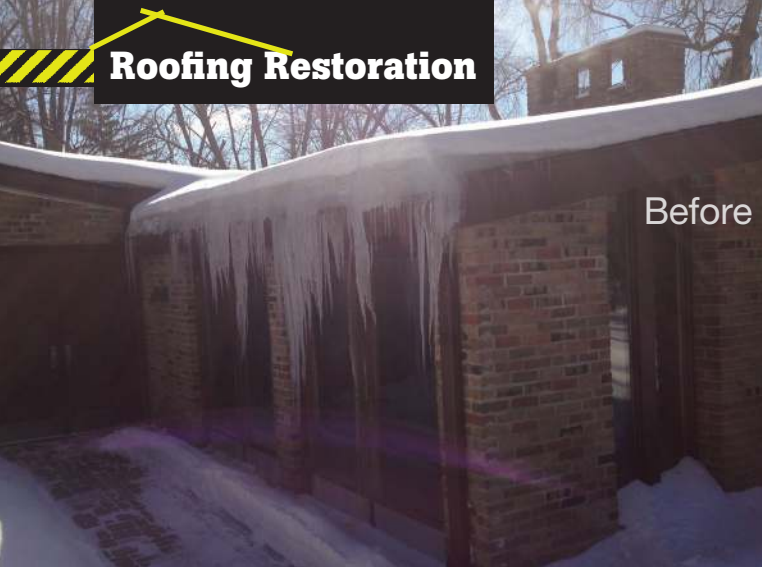
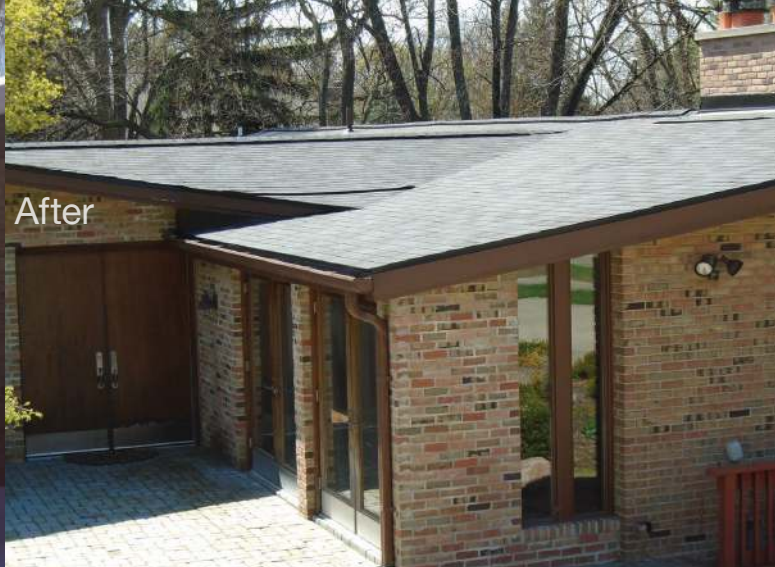
Before After

That knowledge of homes from the outside, in, really came into play when Petrucci and his team tackled a large-scale roofing restoration project in West Bloomfield, Mich., during what felt like an especially long winter. Tremendous ice dams formed, leading to improper ventilation and a lack of insulation. That led to a lot of interior damage including drywall, paint and hardwood floors. Due to cathedral ceilings, workers chose to remove all the plywood and fiberglass insulation from the top, rather than remove all the drywall from the inside. Then, they added 6 inches

of closed-cell foam, sprayed against the back side of the drywall, installed new plywood, shingles and rebuilt the chimney that was falling apart.
